BR930190K hub identification and installation tips

TT 08-007

Tech tip

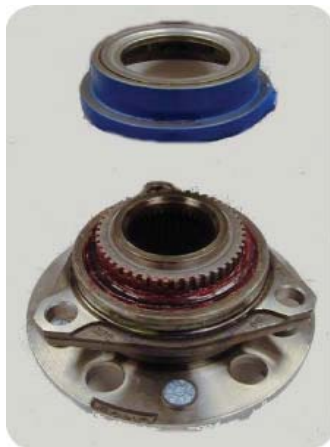
First design

The problem occurs during removal of the hub. During removal of the first design hub, the blue protective cover may become rusted to the knuckle housing and will not come off with the hub unit. In this case, the tone ring sensor is then exposed, which means the old hub does not match either the first design or second design hub. The technician is usually unaware that the protective cover exists. The technician perceives the new hub as incorrect or tries installing the new hub over the old protective cover. In that case, the new hub won't fit. The old protective cover must be removed from the knuckle before installing either replacement style hub.
